Model 2000

Disassembly Instructions and Troubleshooting

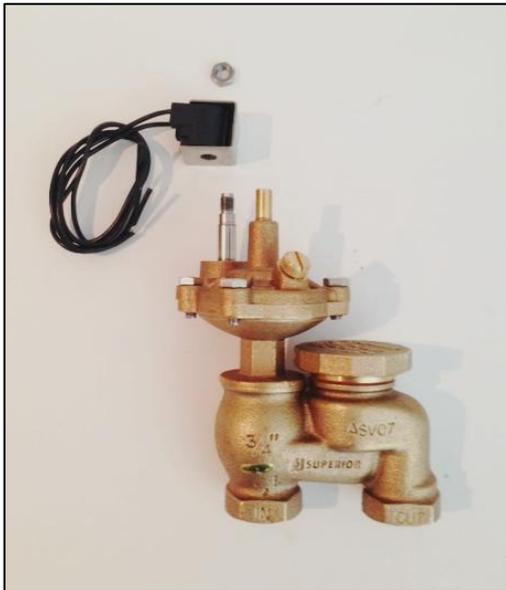
1. Unscrew and remove retaining nut from solenoid post and slide coil and U-frame off of solenoid post.

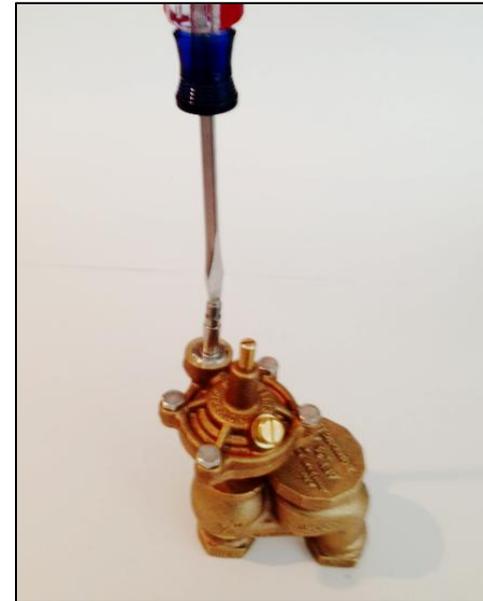
2. Using a flathead screwdriver, unscrew and remove solenoid post from top of adaptor.

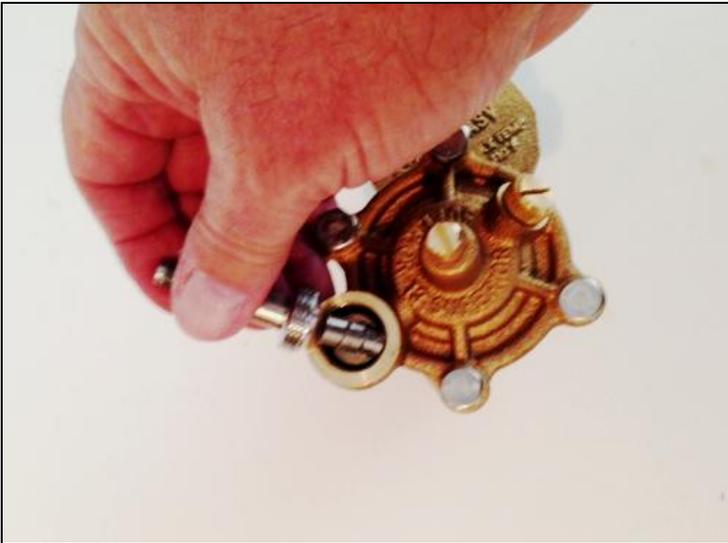
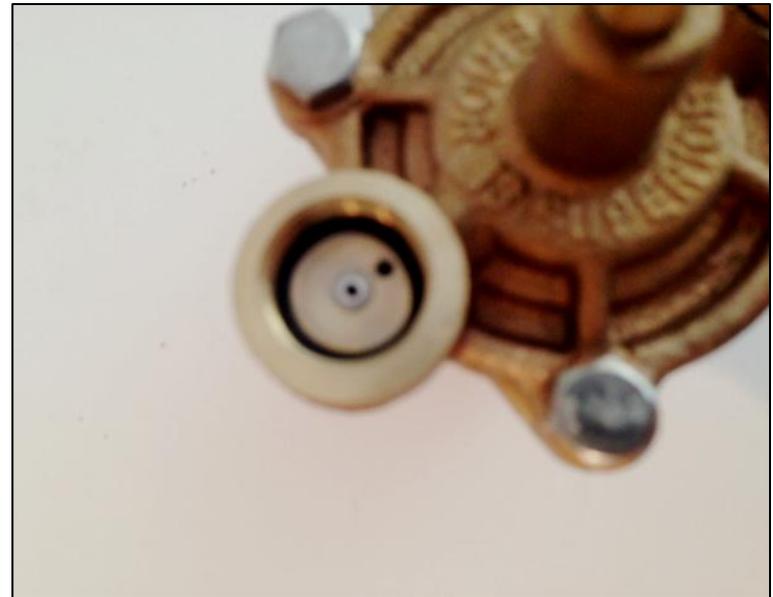
3. Solenoid plunger will drop out of plunger tube as post is removed from solenoid cavity.

Solenoid cavity. The center port is the exhaust port. The other port connects the solenoid cavity to the diaphragm chamber.

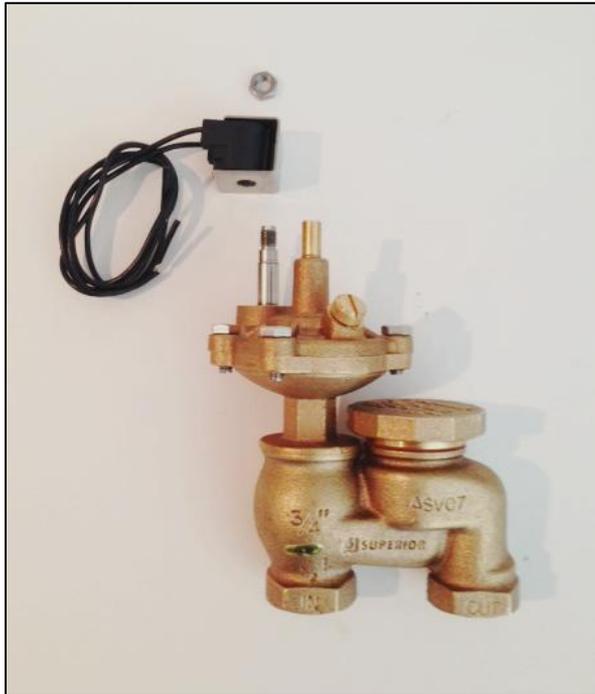
1. After shutting off water supply to the adaptor, remove solenoid retainer nut, coil, and U-frame from solenoid post.

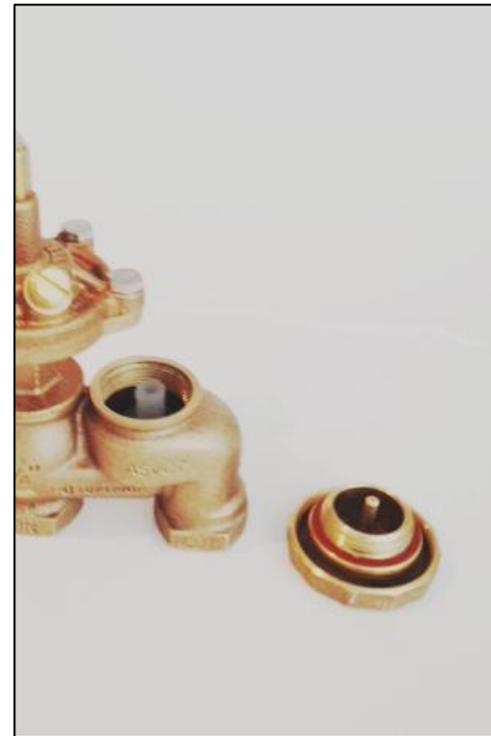
2. Using channel locks, remove anti-siphon cap from valve body.

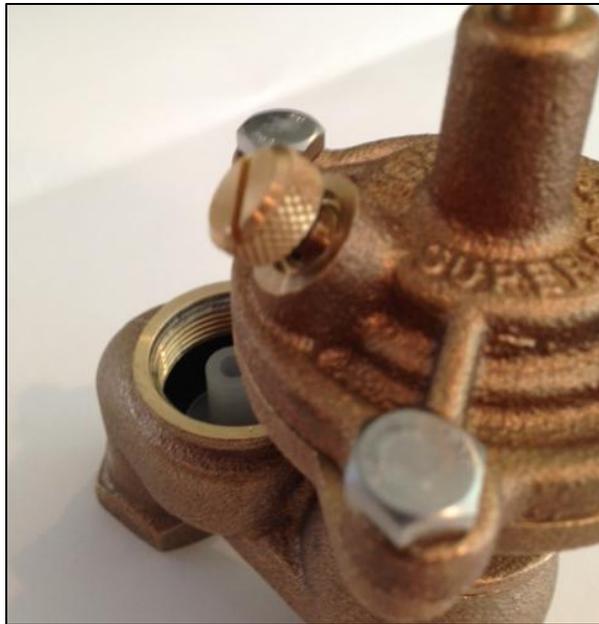
3. Unscrew manual bleeder a few turns to relieve pressure from the top of the diaphragm.

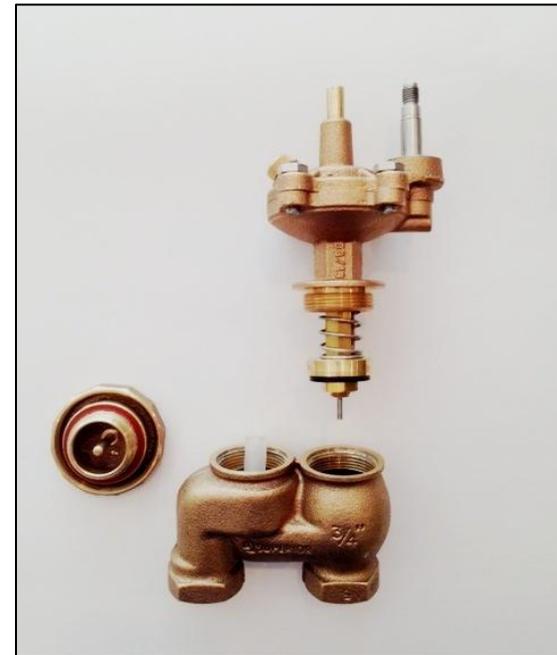
4. Apply a wrench to hex portion (neck) of adaptor and unscrew it from the valve body.

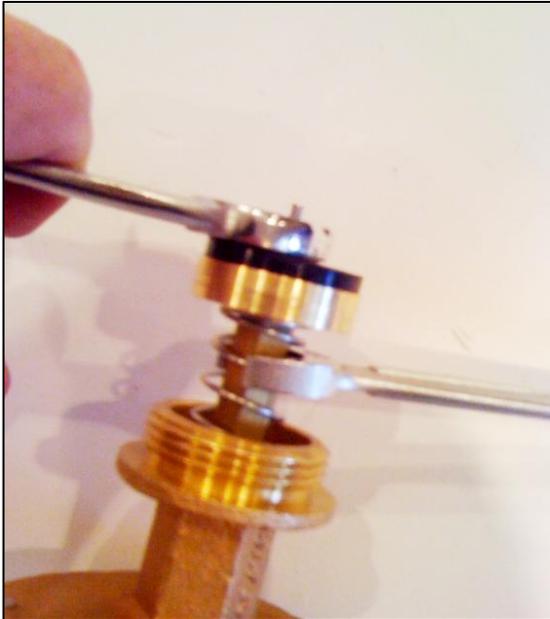
1. Use a 7/16" wrench to apply to shaft and 9/16" wrench to unscrew seat disc retaining nut.

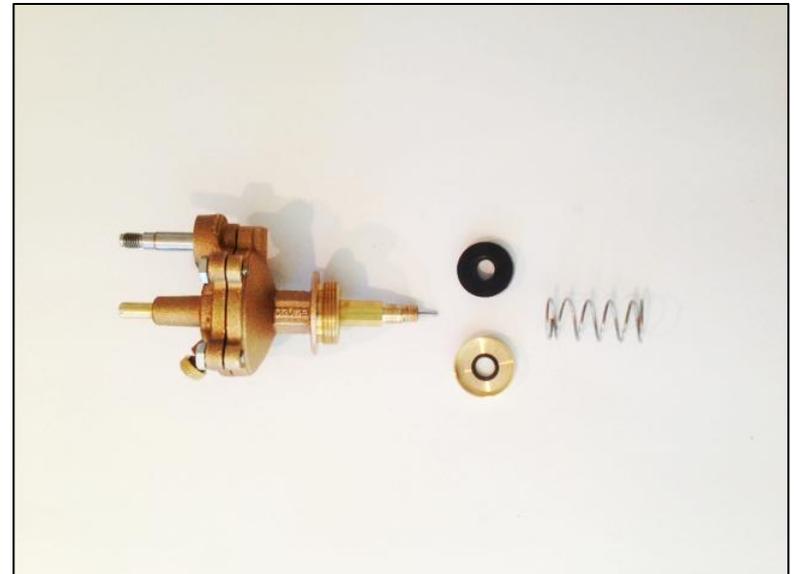
2. Remove seat disc, disc holder and spring from the shaft.

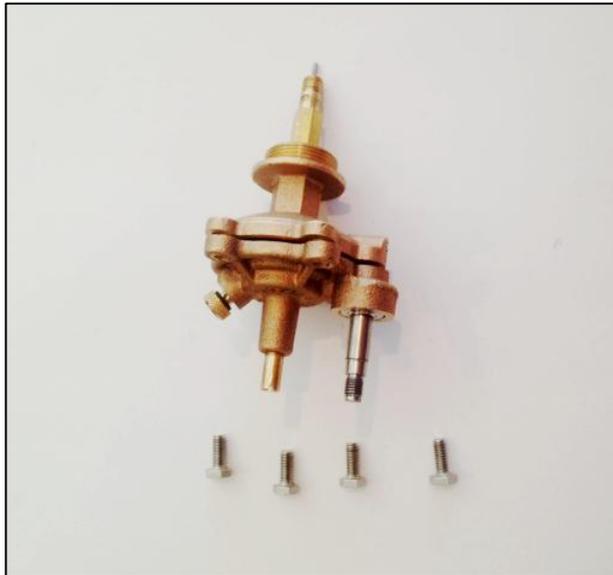
3. Using a 7/16" wrench, remove bolts from top of adaptor.

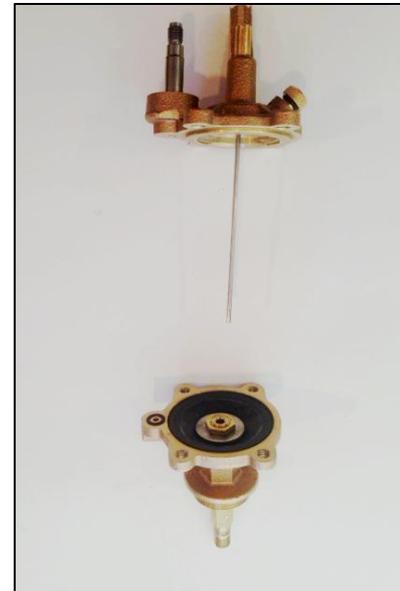
4. Lift top straight up until metering rod clears the top of the diaphragm shaft. It may be necessary to pry the top loose from lower housing using a flathead screwdriver.

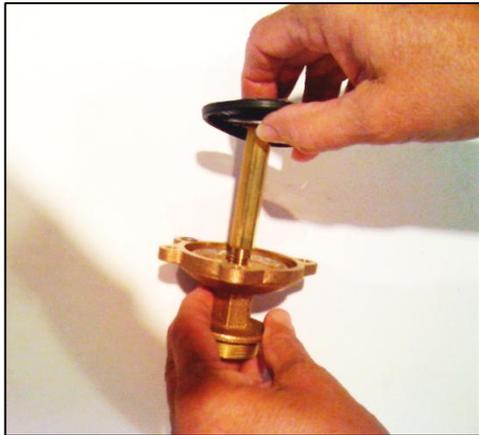
5. Lift and remove diaphragm assembly from lower diaphragm housing.

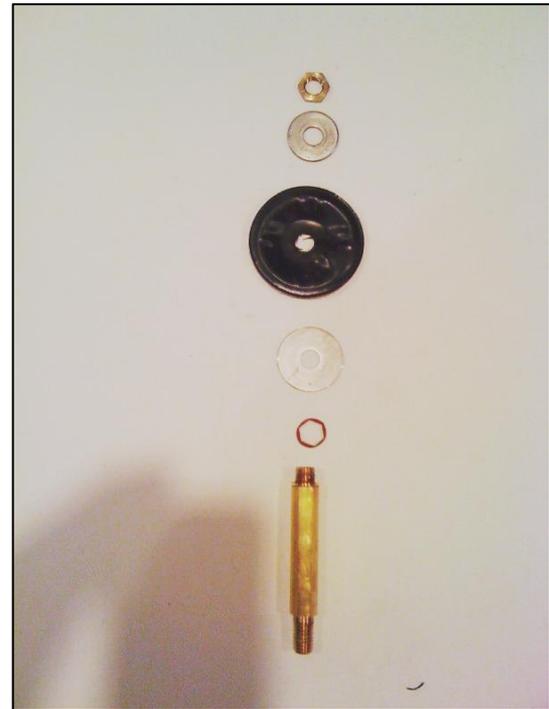
6. To disassemble diaphragm assembly, use a 7/16" wrench to hold shaft, and 9/16" wrench to remove nut at top of diaphragm shaft.

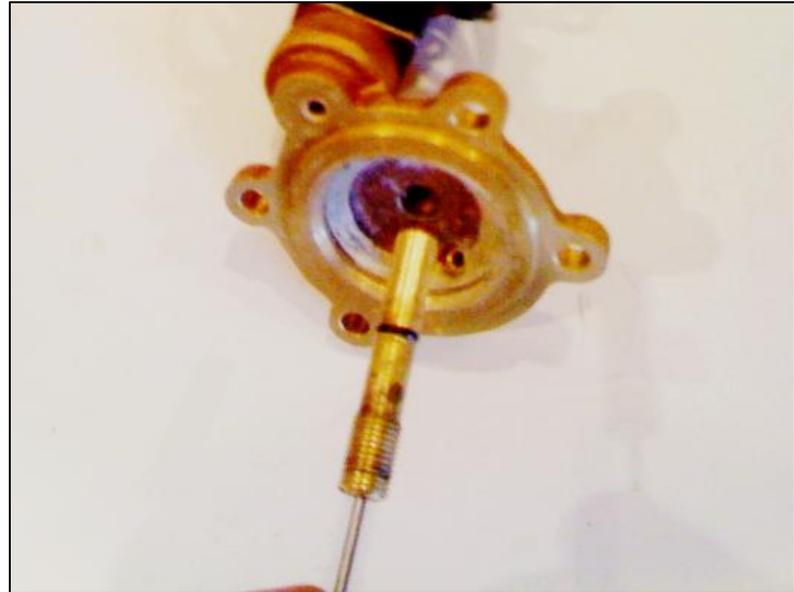
7. To remove flow control stem from top, first use a flathead screwdriver to turn the flow control stem as many turns as possible in clockwise direction. Next, unscrew the flow-control stem from the underside of the top.

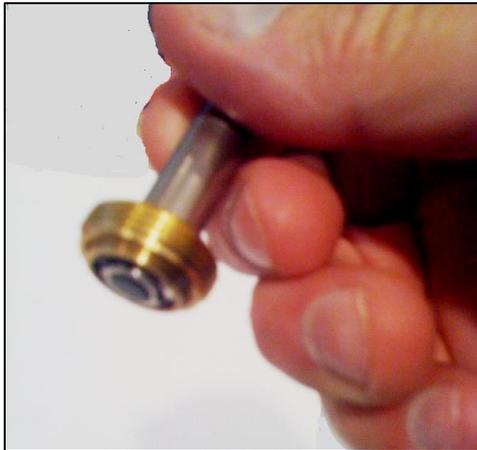
PROBLEM: Valve will not close.

CAUSE #1: Malfunctioning solenoid. Solenoid plunger is unable to seal exhaust port due to debris in solenoid chamber or plunger being stuck in plunger tube and unable to drop.

SOLUTION: Remove debris from solenoid cavity and/or clean plunger tube. Replace stem and plunger assembly if necessary.

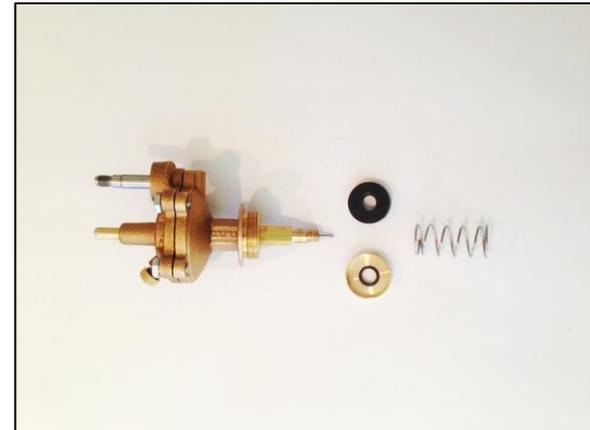
PROBLEM: Valve will not close.

CAUSE #2: Debris in valve body or debris embedded in rubber seat disc prevents rubber seat disc from seating onto brass seat in anti-siphon body.

SOLUTION: Remove adaptor from anti-siphon body and remove debris. If rubber seat disc is pitted, disassemble it from shaft and flip it over or replace if necessary.

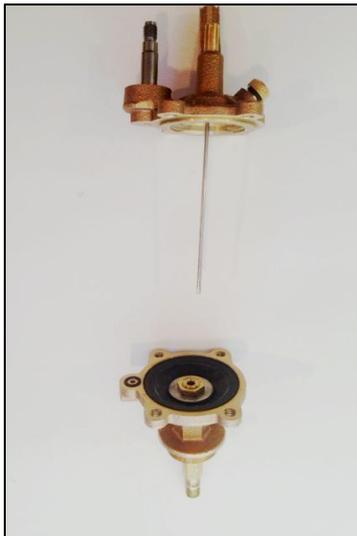
PROBLEM: Valve will not close.

CAUSE #3: Open manual bleeder. If no water exhausts from manual bleeder, the likely cause is a buildup of minerals on the metering rod that is preventing water from entering the diaphragm chamber.

SOLUTION: Remove top of adaptor and clean the metering rod using emery cloth

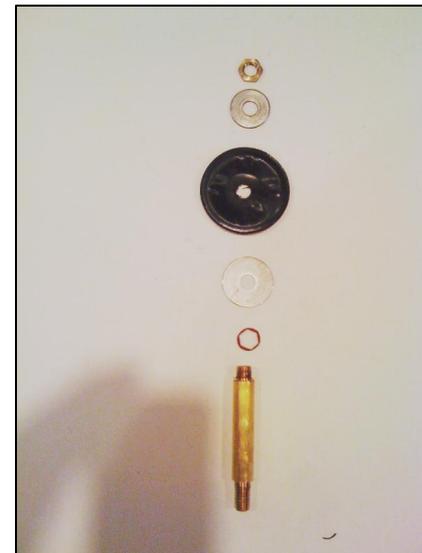
PROBLEM: Valve will not close.

CAUSE #4: Torn Diaphragm.

SOLUTION: Disassemble valve and replace diaphragm .

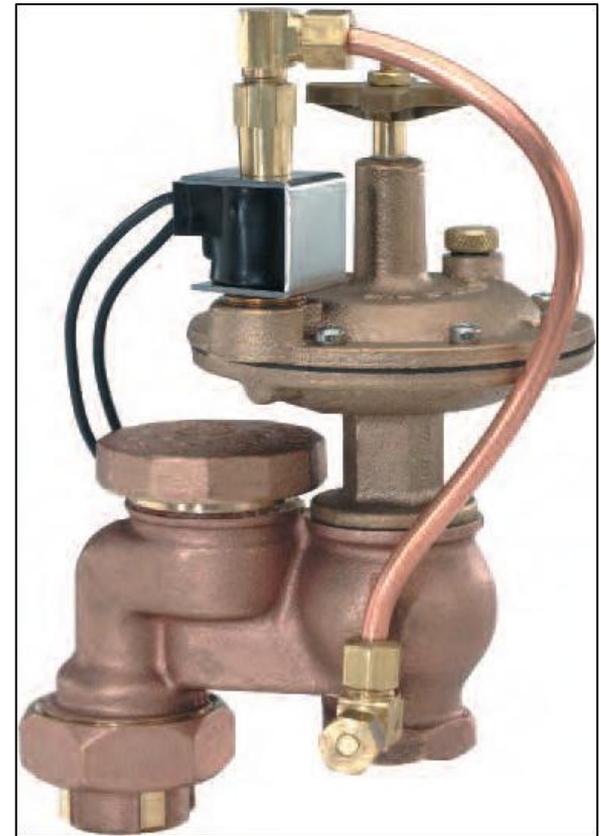
PROBLEM: Valve will not close.

CAUSE #5: Insufficient flow. Irrigation valves and adaptors have a minimum flow requirement in order to close. The larger the valve size, the greater the minimum flow requirement. A $\frac{3}{4}$ " 2000 adaptor has a minimum flow requirement of about 5 GPM.

SOLUTION: Sometimes, reducing the flow by turning the flow control stem clockwise as much as possible without adversely affecting coverage will enable the valve to close. If it works, do not readjust the flow control. If it does not work, then increase flow by adding sprinkler heads or emitters to the system. If that is not possible, then it is recommended that a model 850-DI be used in place of the model 2000. This will necessitate replacing the anti-siphon valve body as well. The model 850-DI, shown in photo at right, has no minimum flow requirement. It was designed to be used in low flow drip irrigation systems.

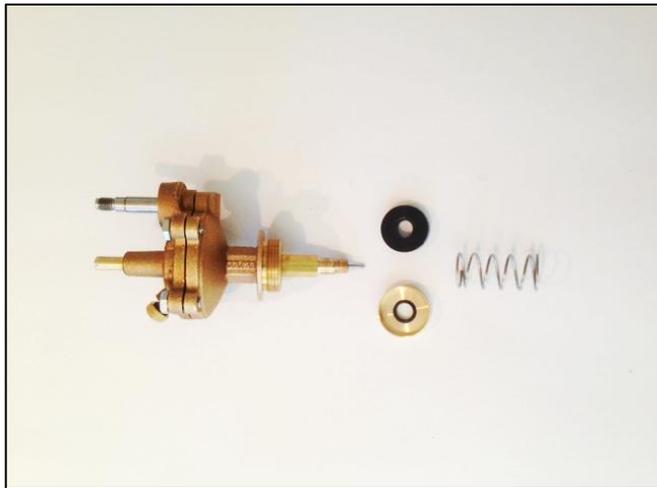
PROBLEM: Water weeps past the valve and seeps out of the lowest head.

CAUSE #1: Small debris under rubber seat disc or pitted rubber seat disc.

SOLUTION: Remove adaptor from anti-siphon body and clean debris. If the rubber seat disc is pitted, remove it, flip it over and reassemble, or replace seat disc.

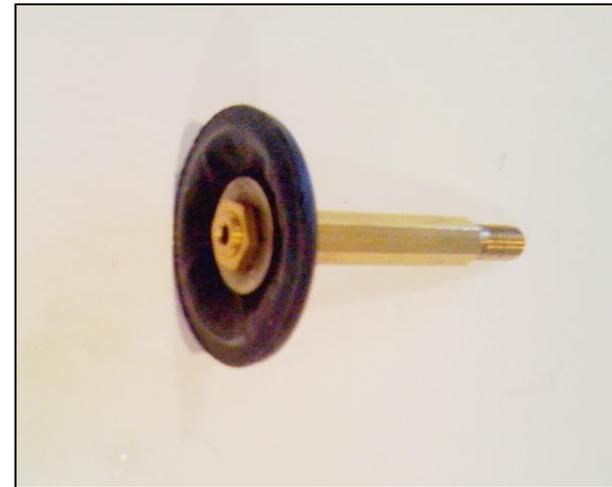
PROBLEM: Water weeps past the valve and seeps out of the lowest head.

CAUSE #2: If there is no evidence of debris or pits in the rubber seat disc, the likely cause is that the nut at top of diaphragm assembly is loose allowing water to seep past the threads of the diaphragm shaft. This eventually causes the threads to erode and the problem becomes worse over time.

SOLUTION: Replace diaphragm assembly or replace adaptor.

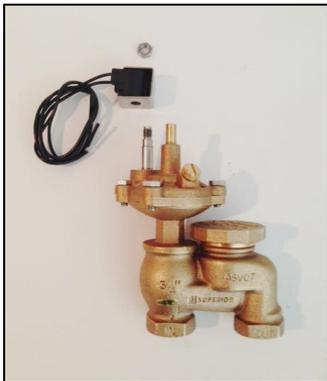
PROBLEM: Valve will not open when energized.

CAUSE #1: Solenoid is not receiving power.

SOLUTION: Place your fingers around the solenoid coil to see if it is receiving power. There should be a slight vibration and humming. If not, verify that there is output at the controller by using a volt meter. If there is electrical output (24 VAC) then the problem is either a bad coil or broken wire. Check the coil by disconnecting solenoid lead wires from valve wires and measure ohms with an ohm meter. A reading of 24 to 27 ohms means the coil is OK. If reading is 0 or infinity, replace coil.

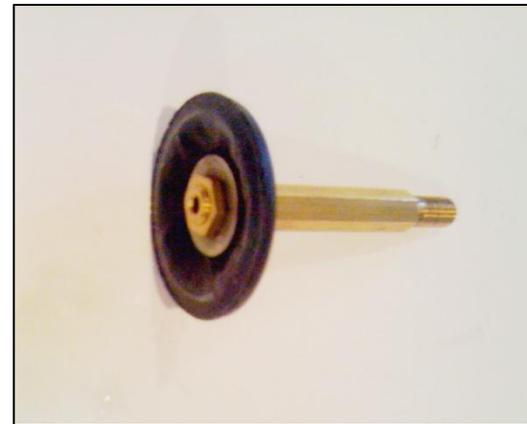
PROBLEM: Valve will not open or only opens part way when energized.

CAUSE #2: Enlarged inlet orifice at bottom of diaphragm shaft is allowing water to enter diaphragm chamber at a rate greater than it can exit through solenoid exhaust port. Because the inlet orifice is brass, it can enlarge over time in high pressure/velocity conditions.

SOLUTION: Replace diaphragm assembly (which includes diaphragm shaft) or replace adaptor.

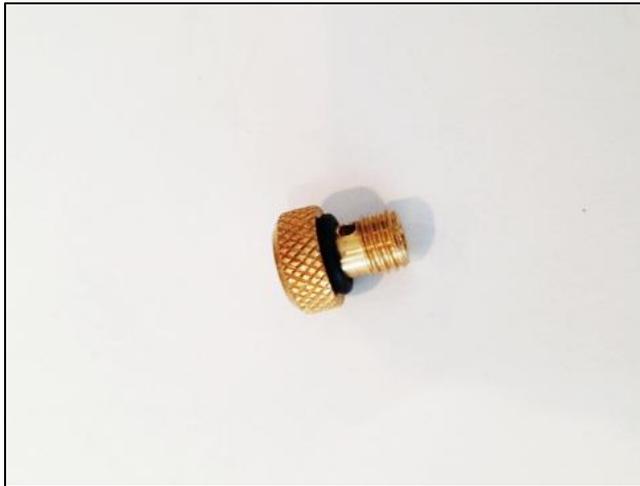
PROBLEM: Water leaks out around manual bleed valve.

CAUSE #1: Damaged o-ring on bleed screw.

SOLUTION: Replace bleed screw.

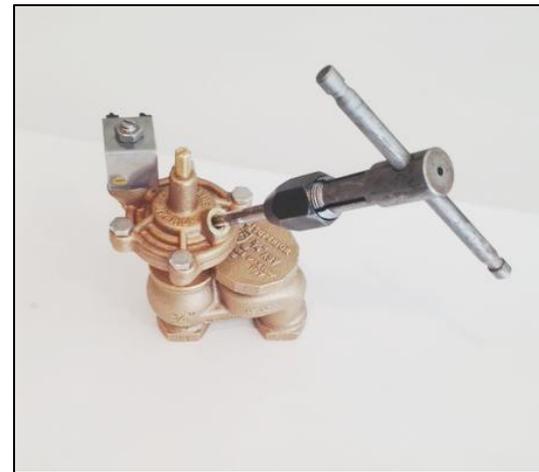
PROBLEM: Water leaks out around manual bleed screw.

CAUSE #2: Bleed screw cannot be screwed all the way down due to disappearing threads in opening. This is caused by a transfer of metal from threads on bleed screw to female threads in opening.

SOLUTION: Using a 5/6"-24 tap, rethread opening and replace bleed screw with a new one.

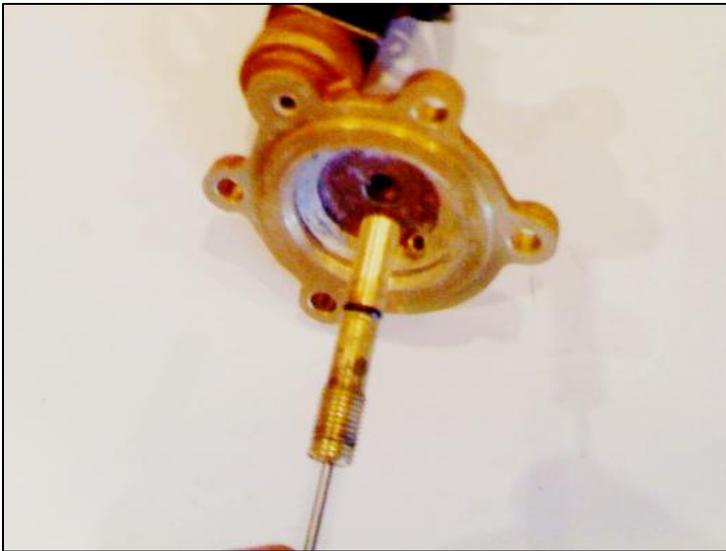
PROBLEM: Water leaks out around flow control stem.

CAUSE: Damaged o-ring on the flow-control stem.

SOLUTION: Remove flow-control stem from bonnet and replace o-ring. Apply silicone grease to the o-ring before re-assembling it into the bonnet.

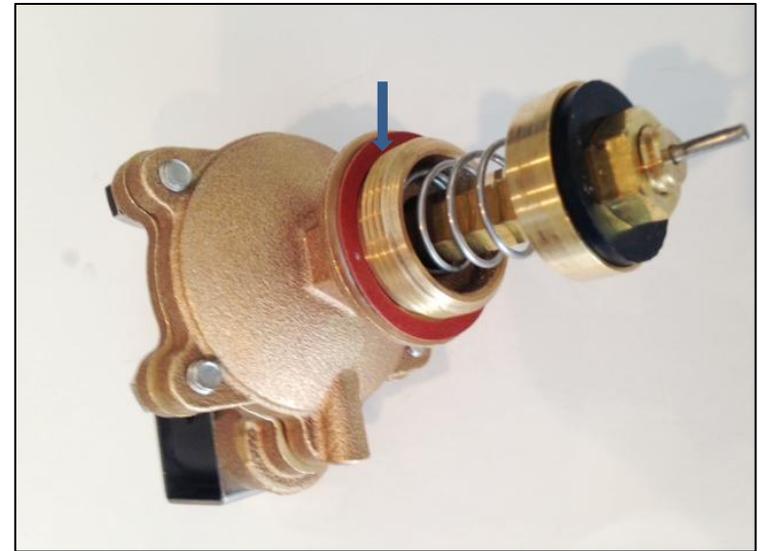
PROBLEM: Water leaks out between adaptor and anti-siphon body.

CAUSE: Damaged body fiber washer.

SOLUTION: Replace damaged fiber body washer
