# Model 600

## Disassembly Instructions and Troubleshooting

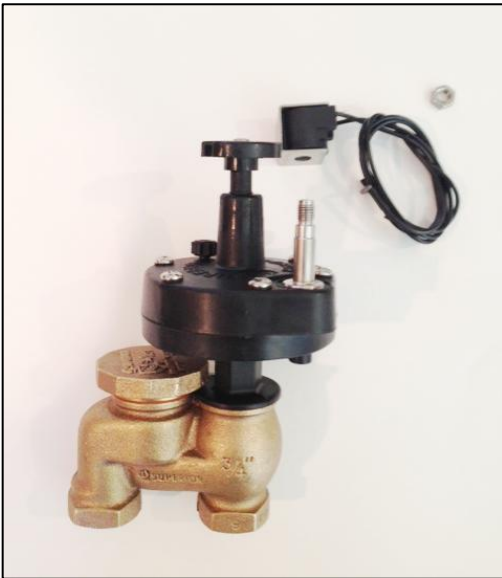
1. Remove retaining nut (or yellow retaining cap on earlier models) from solenoid post and slide coil and U-frame off of solenoid post.

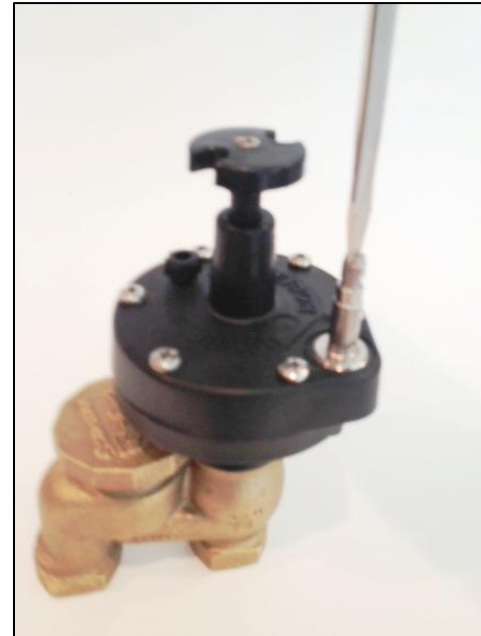
2. Using a flathead screwdriver, unscrew and remove solenoid post from top of adaptor.

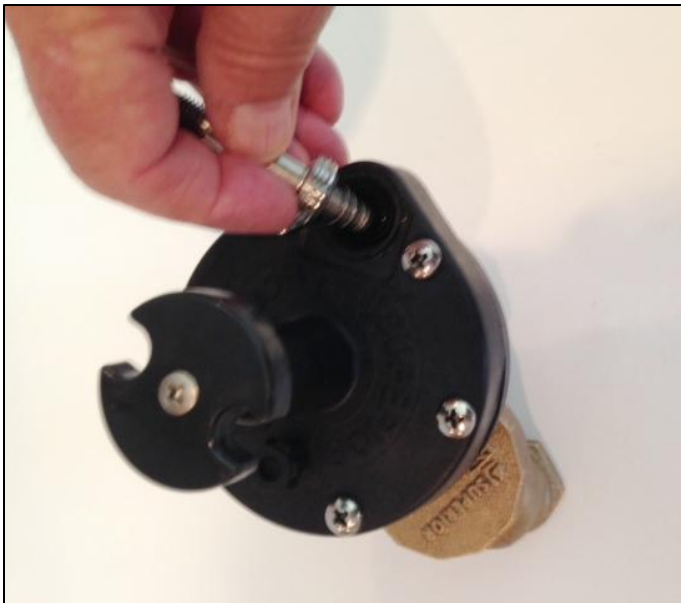
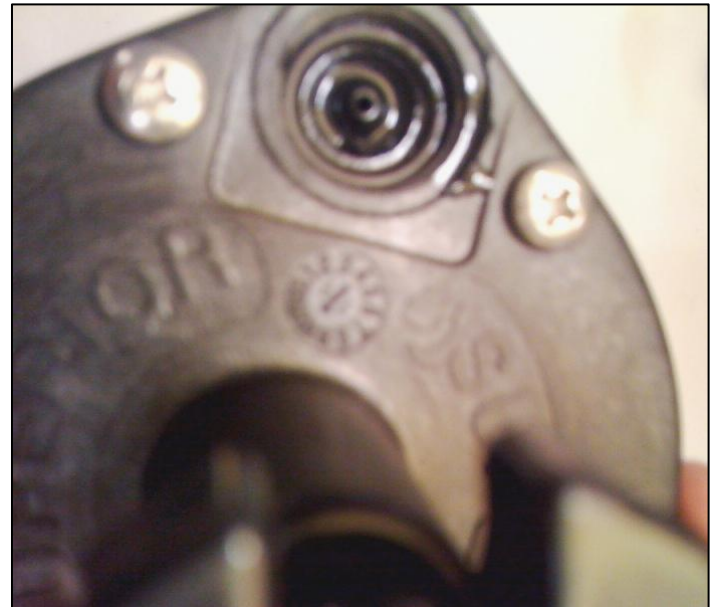
3. Solenoid plunger will drop out of plunger tube as post is removed from solenoid cavity.

Solenoid cavity. The center port is the exhaust port. The other port connects the solenoid cavity to the diaphragm chamber.

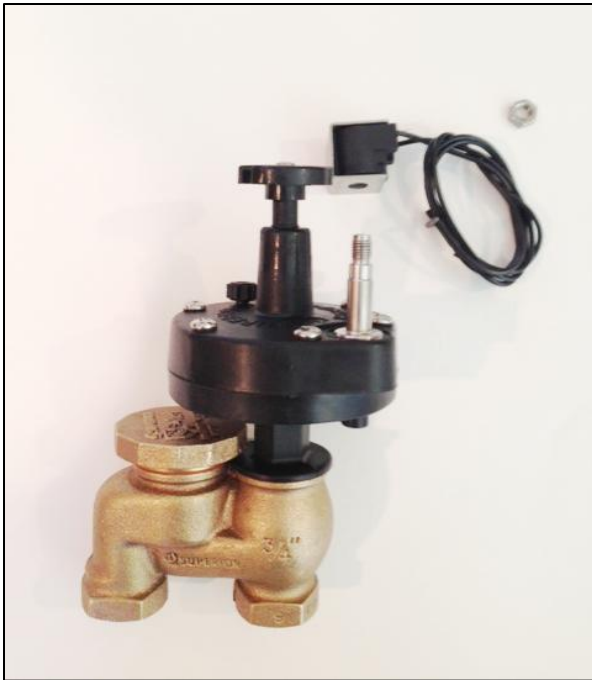
1. After shutting off water supply to the adaptor, remove solenoid retainer nut, coil, and U-frame from solenoid post.

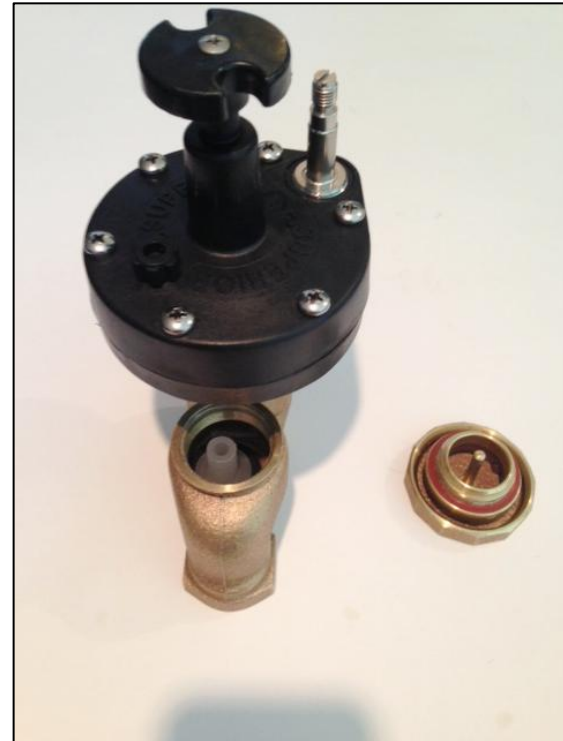
2. Using channel locks, remove anti-siphon cap from valve body.

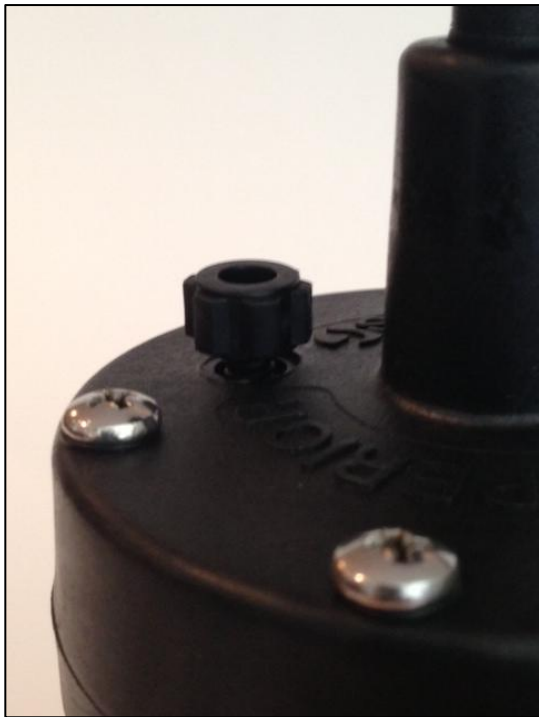
3. Unscrew manual bleeder a few turns to relieve pressure from the top of the diaphragm.

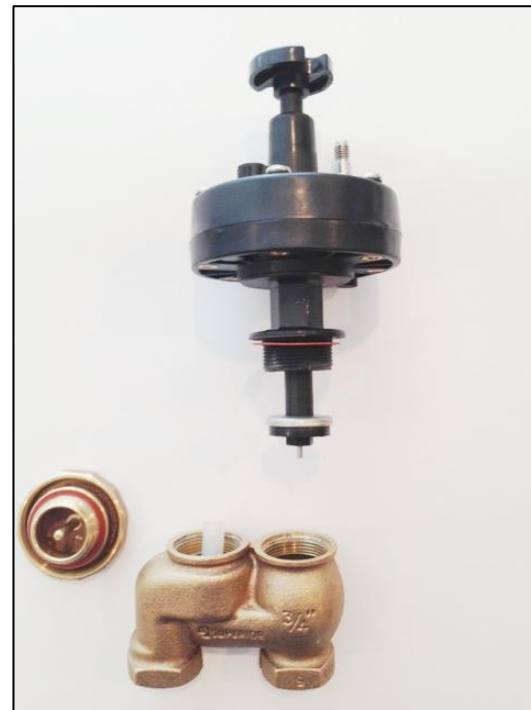
4. Apply a wrench to hex portion (neck) of adaptor and unscrew it from the valve body.

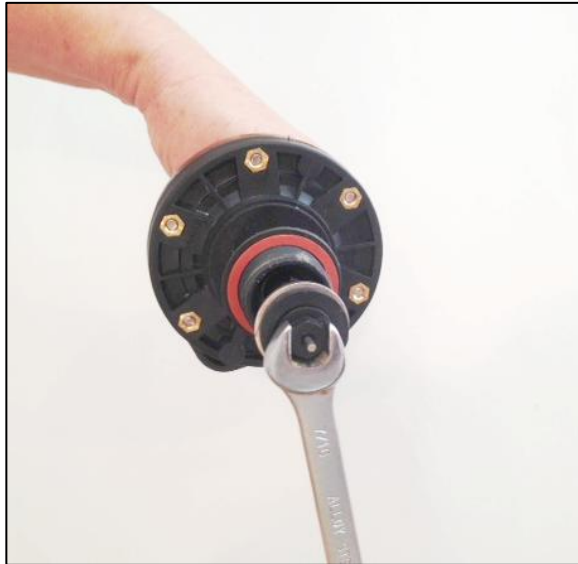
1. Using a 7/16" wrench, unscrew orifice screw from bottom of diaphragm shaft.

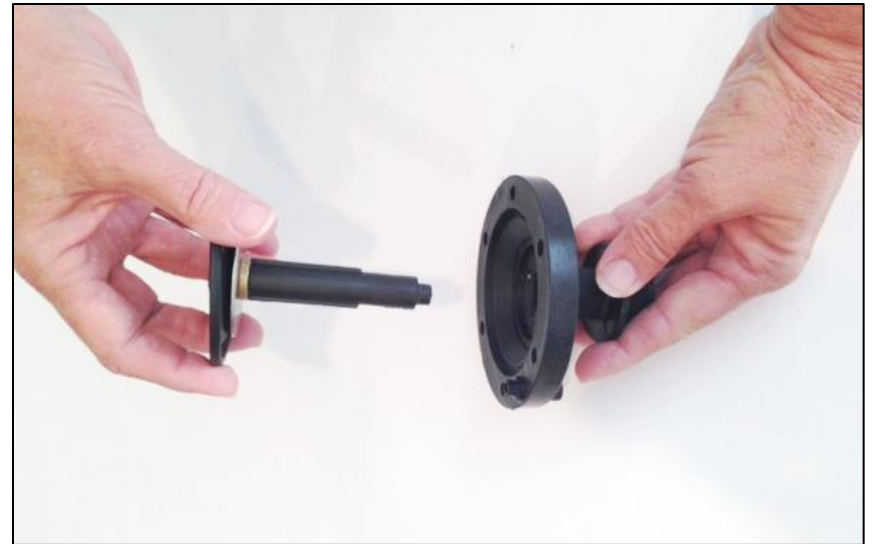
**4.** Remove spring and lift diaphragm assembly out of lower diaphragm housing.

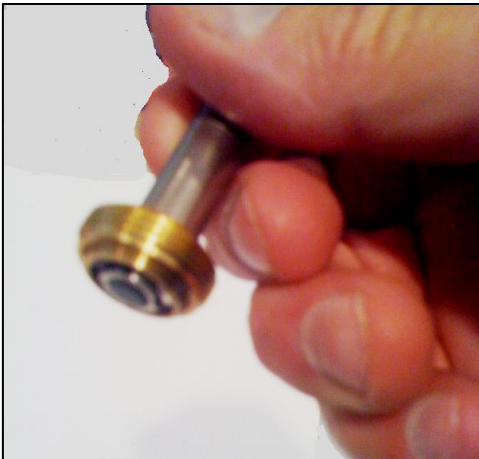
**CAUSE #1:** Malfunctioning solenoid. Solenoid plunger is unable to seal exhaust port due to debris in the solenoid chamber or plunger stuck in plunger tube and will not drop when solenoid is de-energized.

**SOLUTION:** Remove debris from solenoid cavity and/or clean solenoid plunger and plunger tube. Replace stem and plunger assembly if necessary.

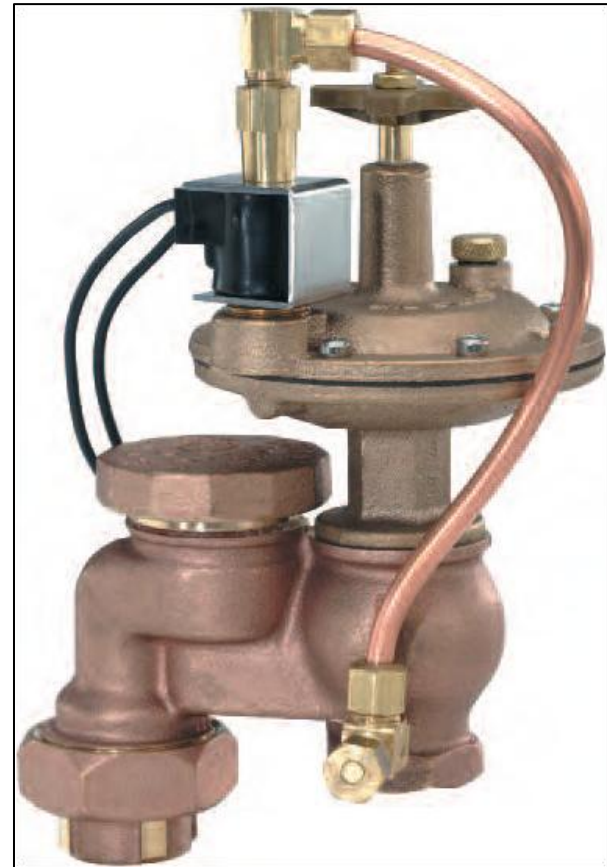
**CAUSE #5:** Insufficient flow. Irrigation valves and adaptors have a minimum flow requirement in order to close. The larger the valve size, the greater the minimum flow requirement. A  $\frac{3}{4}$ " 600 adaptor has a minimum flow requirement of about 5 GPM.

**SOLUTION:** Sometimes, reducing the flow by turning the flow control handle clockwise as much as possible without adversely affecting coverage will enable the valve to close. If it works, do not readjust the flow control. If it does not work, then increase flow by adding sprinkler heads or emitters to the system. If that is not possible, then it is recommended that a model 850-DI be used in place of the model 800. This will necessitate replacing the anti-siphon valve body as well. The model 850-DI, shown in photo at right, has no minimum flow requirement. It was designed to be used in low flow drip irrigation systems.

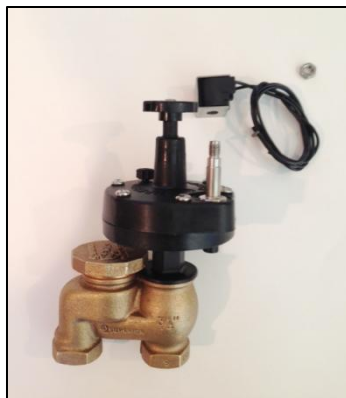
**CAUSE #1:** Solenoid is not receiving power.

**SOLUTION:** Place your fingers around the solenoid coil to see if it is receiving power. There should be a slight vibration and humming. If not, verify that there is output at the controller by using a volt meter. If there is electrical output (24 VAC) then the problem is either a bad coil or broken wire. Check the coil by disconnecting solenoid lead wires from valve wires and measure ohms with an ohm meter. A reading of 24 to 27 ohms means the coil is OK. If reading is 0 or infinity, replace coil.

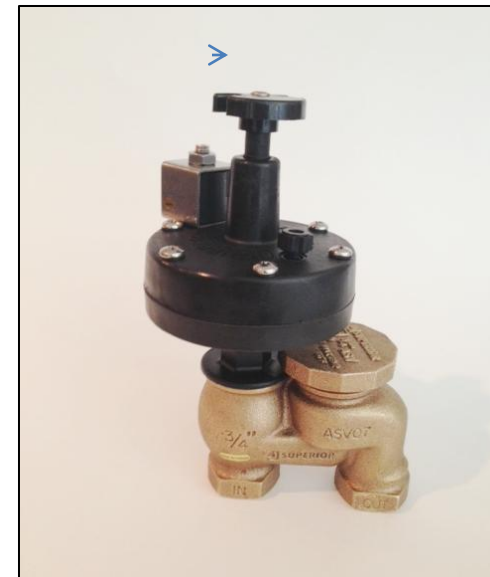
**CAUSE #2:** Flow-control handle is turned all the way closed (clockwise).

**SOLUTION:** While solenoid is energized, turn flow-control handle counter-clockwise a half turn at a time until sufficient coverage is observed.
