950 Series

Disassembly Instructions and Troubleshooting

(Also Applies to 950PRS)

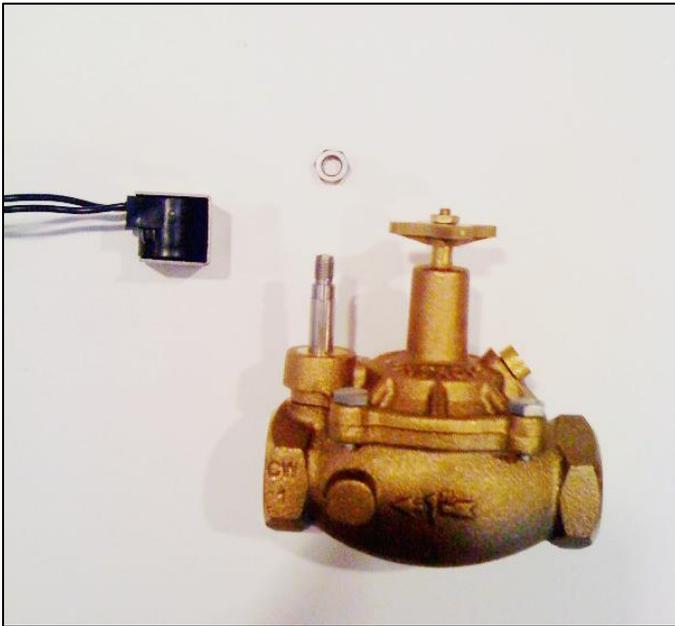
1. Unscrew and remove retaining nut from solenoid post and slide coil and U-frame off of solenoid post.

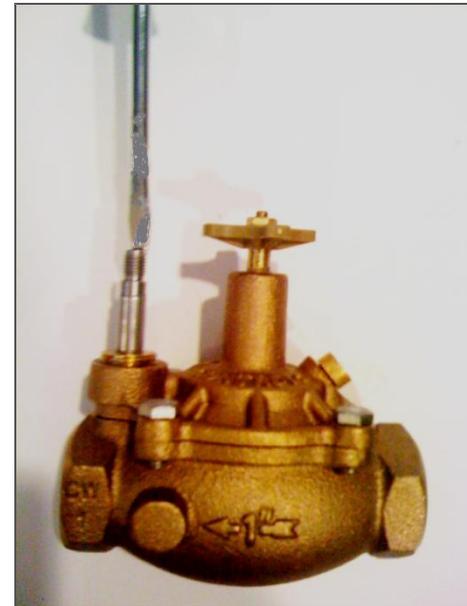
2. Using a flathead screwdriver, unscrew and remove solenoid post from top of valve.

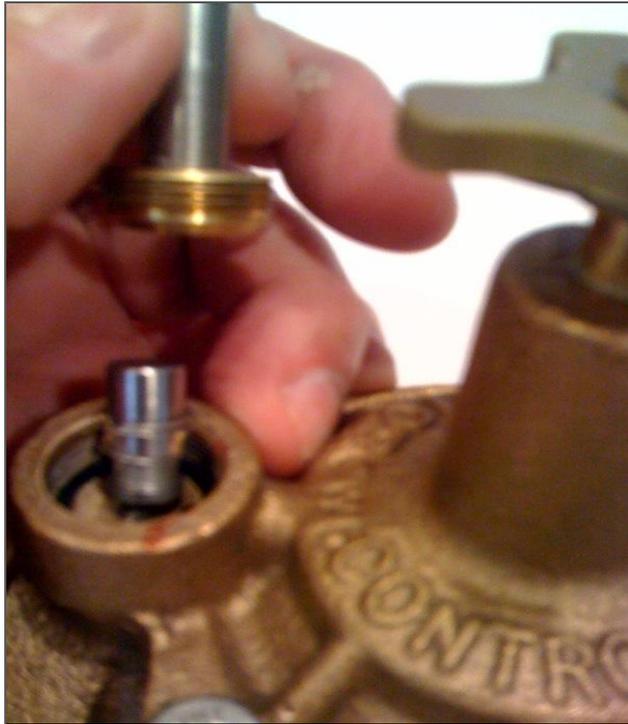
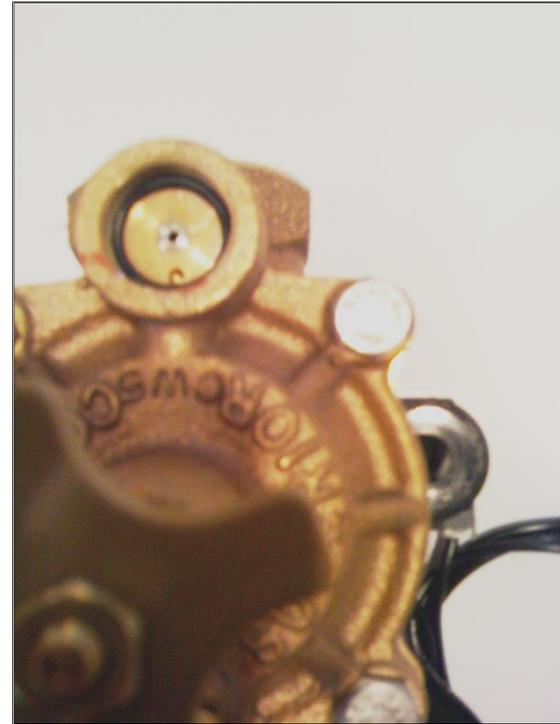
3. Solenoid plunger will drop out of plunger tube as post is removed from solenoid cavity.

Solenoid cavity. The center port is the exhaust port. The other port connects the solenoid cavity to the diaphragm chamber

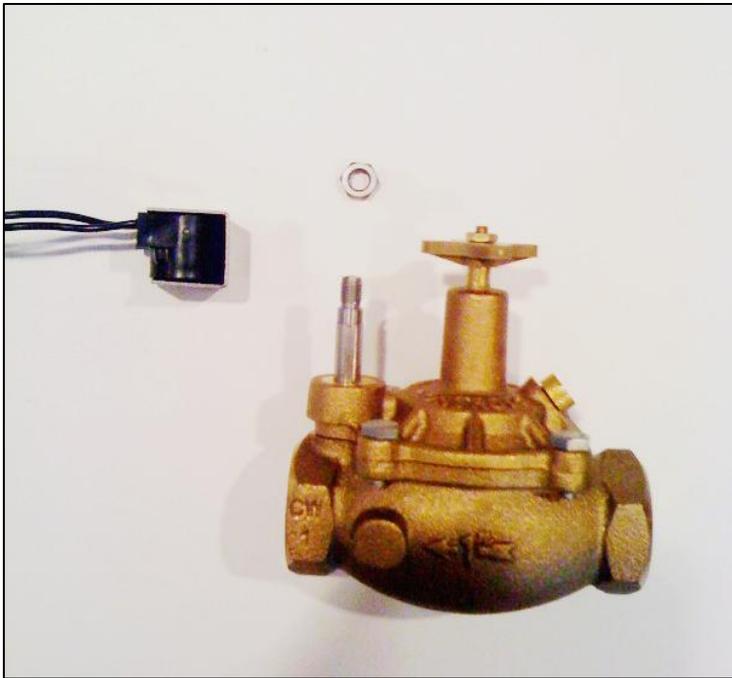
1. Remove solenoid retainer nut and slide solenoid coil and U-frame off of solenoid post

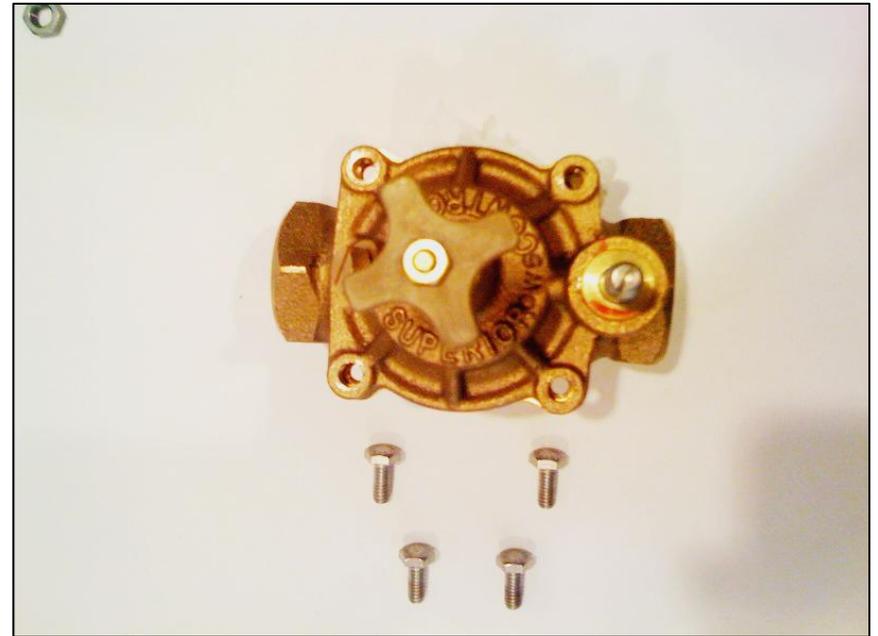
2. Unscrew bolts that fasten valve bonnet to valve body.

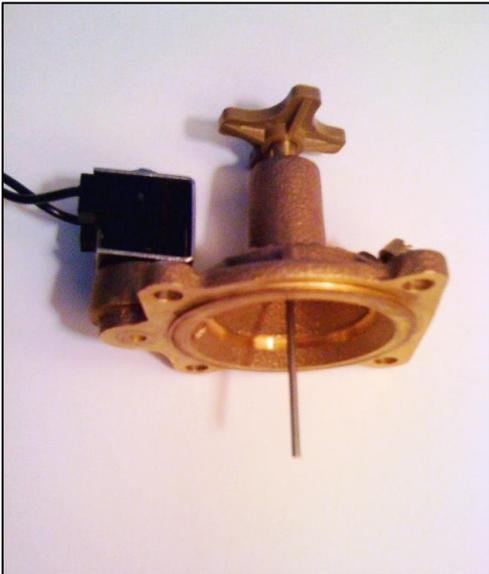
3. Lift bonnet straight up off of valve body taking care that the metering in bonnet exits top of diaphragm shaft.

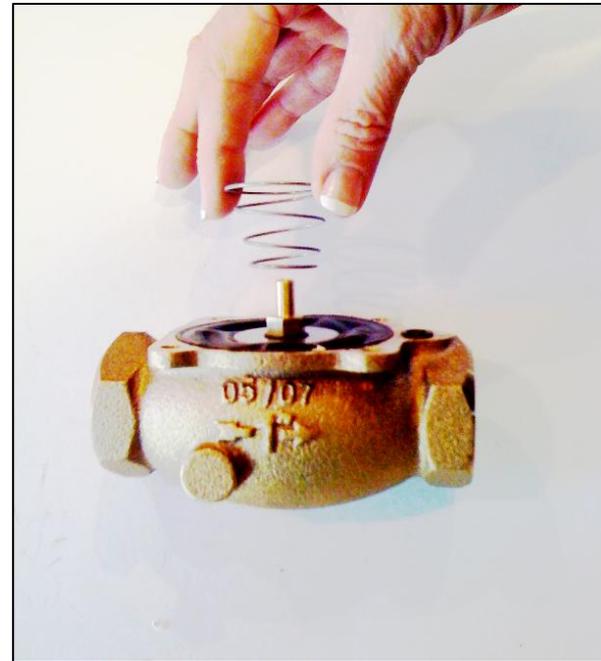
4. Remove diaphragm spring from top of diaphragm assembly

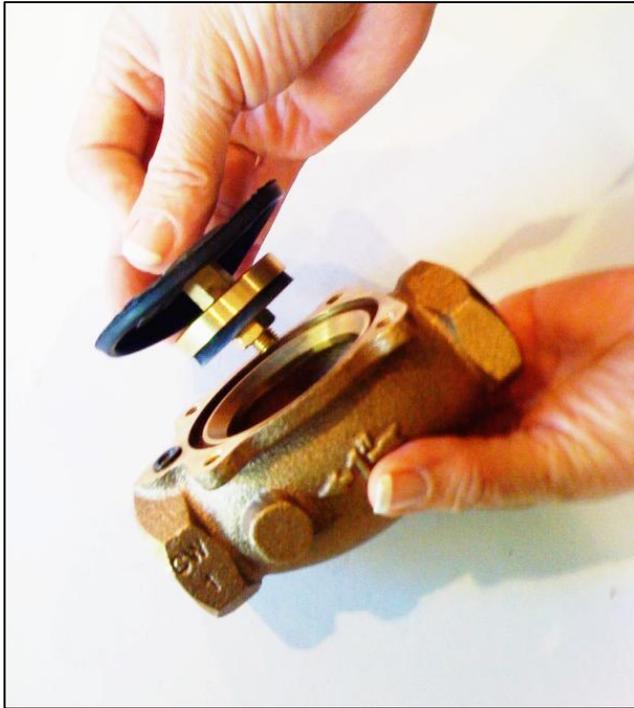
5. Remove diaphragm assembly from valve body.

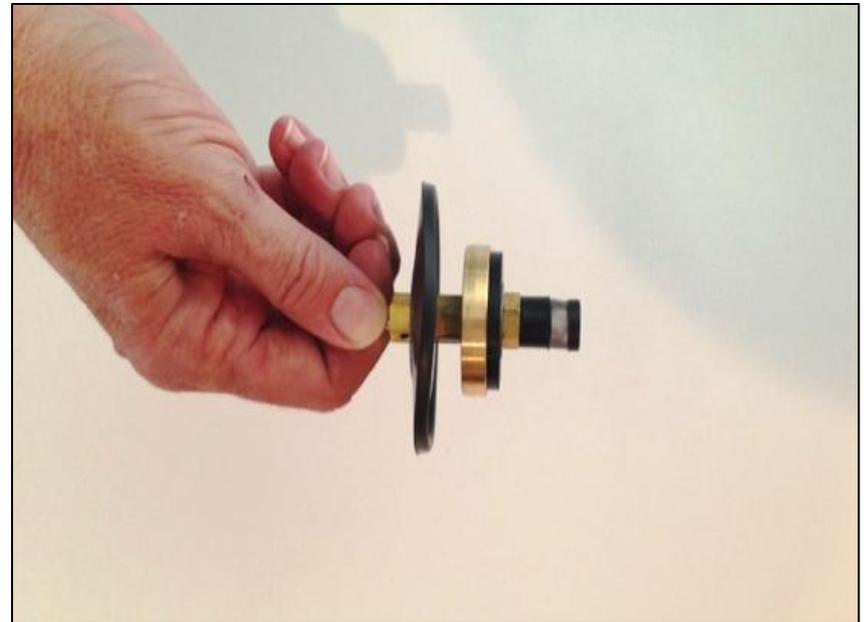
6. This photo shows the diaphragm assembly of the 950DW, 950DWIB, and 950PRS. The only difference is the filter that is screwed onto the bottom of the shaft.

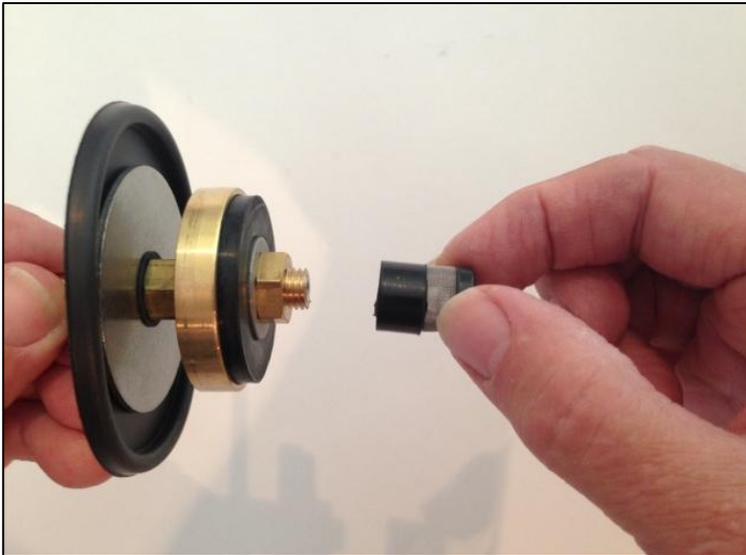
8. For 950DW, 950DWIB, and 950PRS models, unscrew filter from bottom of shaft.

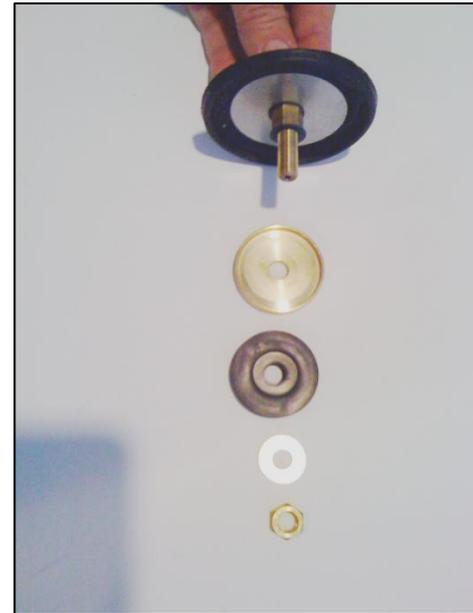
9. To access rubber seat disc, unscrew retainer nut from bottom of shaft and remove retaining washer, brass disc-holder, and rubber seat disc.

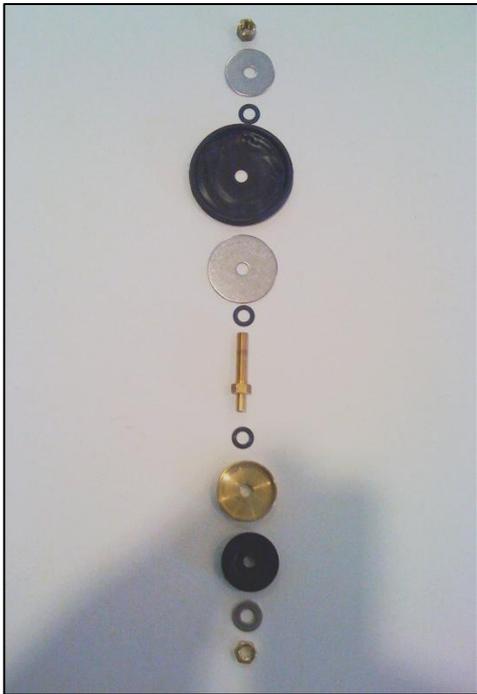
7. Completely disassembled diaphragm assembly.

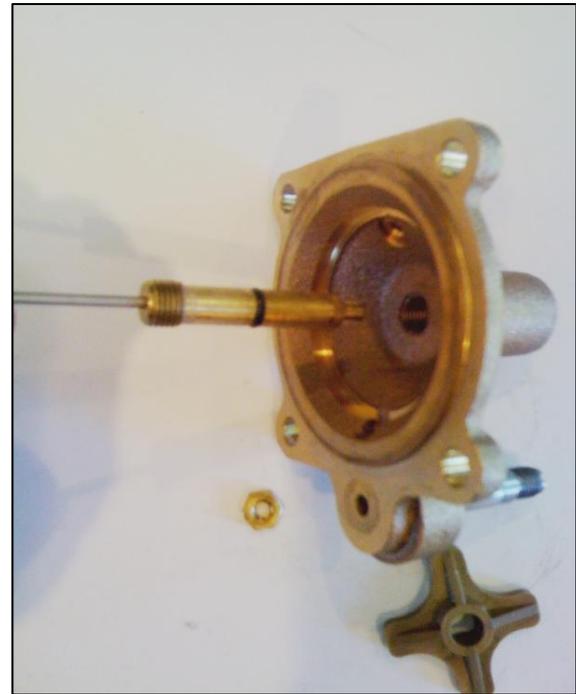
8. To remove flow control stem from bonnet, remove nut and cross-handle from top of stem, then unscrew flow control from underside of bonnet.

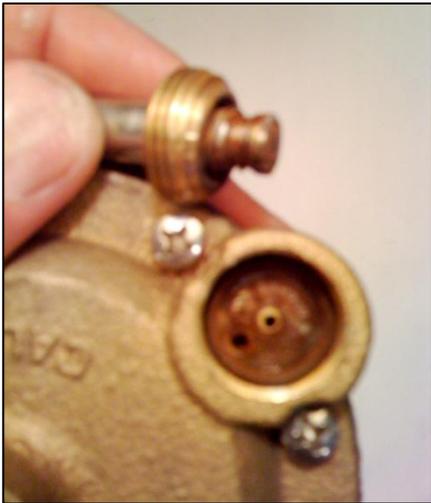
PROBLEM: Valve will not close.

CAUSE #1: Malfunctioning solenoid. Solenoid plunger is unable to seal exhaust port due to debris in solenoid cavity or plunger being stuck in plunger tube and unable to drop.

SOLUTION: Remove debris from solenoid and/or clean plunger and plunger tube. Replace stem and plunger assembly if necessary.

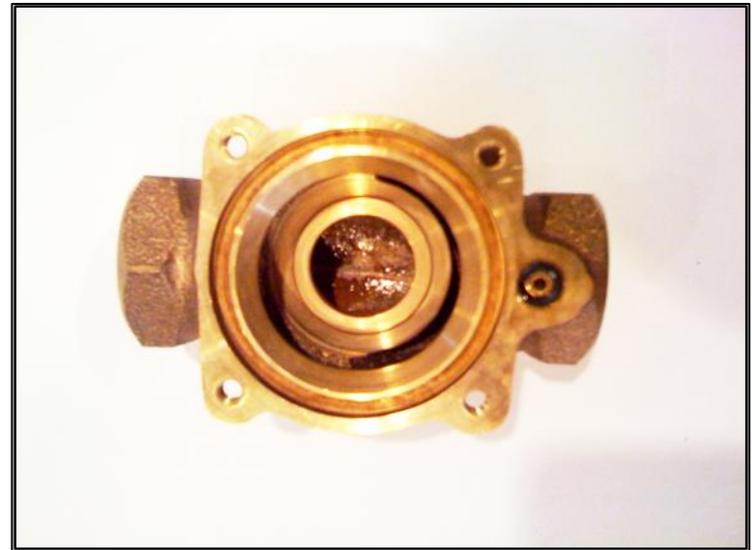
PROBLEM: Valve will not close.

CAUSE #2: Debris in valve body prevents rubber seat from fully closing onto brass seat.

SOLUTION: Remove debris from valve body.

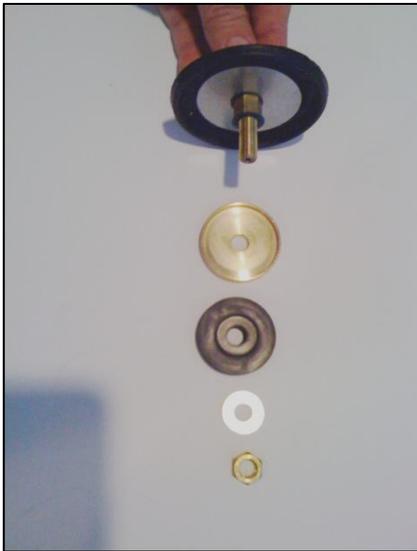
PROBLEM: Valve will not close (or closes but weeps).

CAUSE #3: Debris embedded in rubber seat of diaphragm assembly or rubber seat is pitted.

SOLUTION: Disassemble lower portion of diaphragm assembly, flip rubber seat disc or replace with a new one.

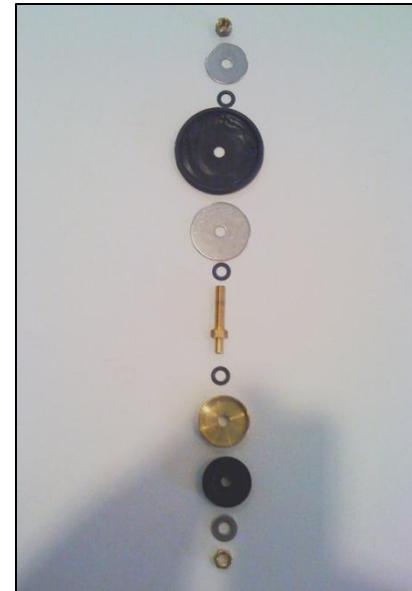
PROBLEM: Valve will not close.

CAUSE #4: Torn diaphragm.

SOLUTION: Replace diaphragm assembly or disassemble diaphragm assembly and replace diaphragm.

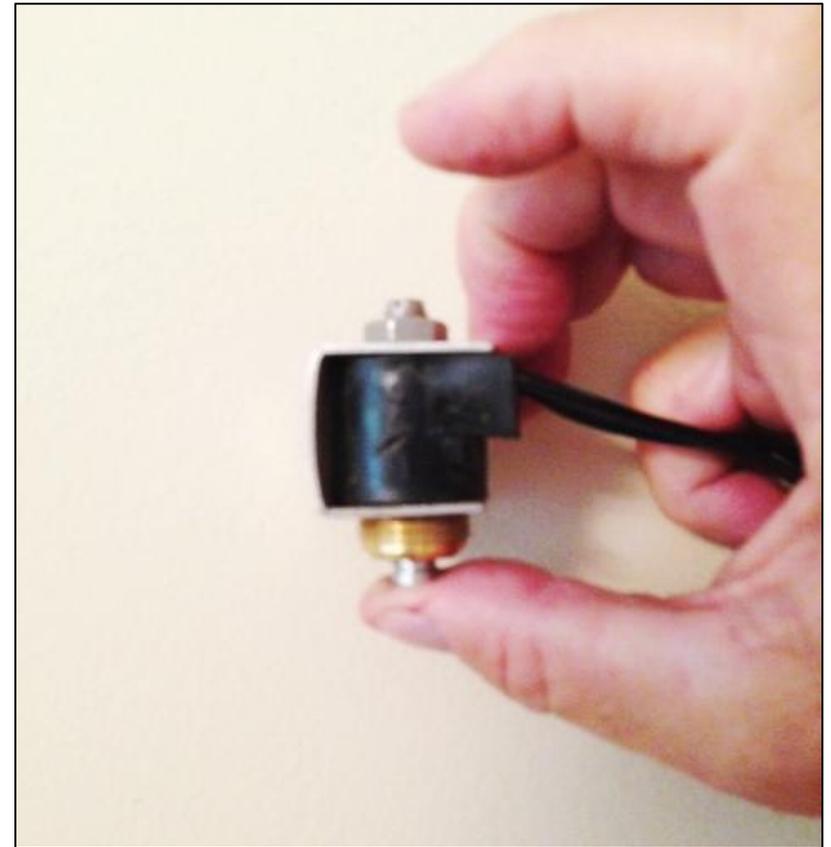
PROBLEM: Valve will not open.

CAUSE #1: Solenoid is not receiving power. Check as follows: 1) Energize solenoid at controller. The solenoid should vibrate enough that it can be felt when coil is touched. 2) As an additional check, remove coil and solenoid stem and plunger from bonnet. Have another person energize solenoid at controller while you are holding solenoid with thumb pressing up on plunger so that plunger is most of the way up plunger tube. Plunger should be sucked up all the way in tube when coil is energized.

If solenoid is not receiving power, disengage solenoid lead wires from valve wires and go to controller with solenoid assembly. Attach one solenoid lead to common terminal and other to a station terminal. Energize the station while holding solenoid in manner described above. If solenoid plunger is sucked into cylinder, then solenoid is OK. Problem is damaged wire between controller and valve.

SOLUTION: Replace solenoid coil if bad.

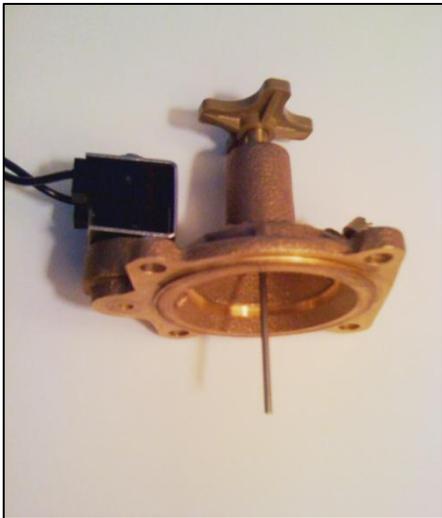
PROBLEM: Valve will not open.

CAUSE #2: Clogged inlet orifice as indicated by water not exiting manual bleeder when opened. The likely cause is a mineral buildup on metering rod.

SOLUTION: Remove bonnet assembly and clean metering rod with emery cloth.

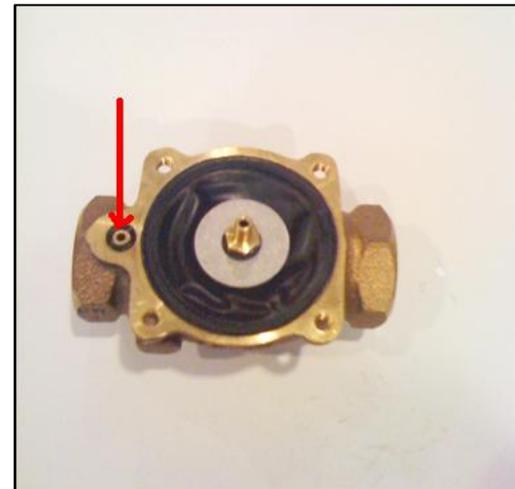
PROBLEM: Valve will not open.

CAUSE #3: Clogged solenoid exhaust port.

SOLUTION: Run a wire down exhaust port. If necessary, remove bonnet and run a drill down exhaust port into opening of valve.

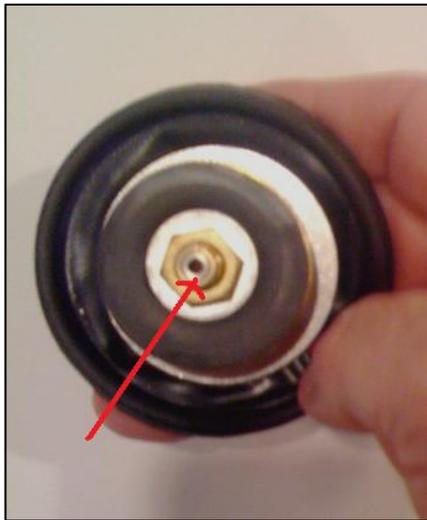
PROBLEM: Valve will not open.

CAUSE #4: Dislodged stainless steel inlet orifice enabling water to enter upper diaphragm chamber faster than it can exit through the solenoid exhaust port. This condition is revealed by an excessive amount of water exhausting out of manual bleeder when opened.

SOLUTION: Replace diaphragm shaft .

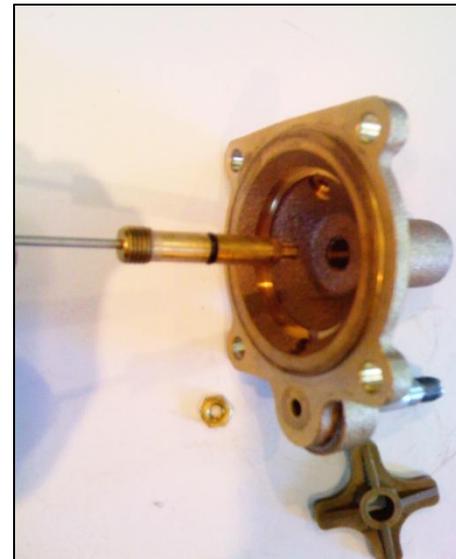
PROBLEM: Water leaks out around flow-control stem.

CAUSE: Torn or damaged flow-control o-ring.

SOLUTION: Remove flow-control stem from bonnet and replace o-ring. Apply silicone grease to o-ring before reassembling stem into bonnet.

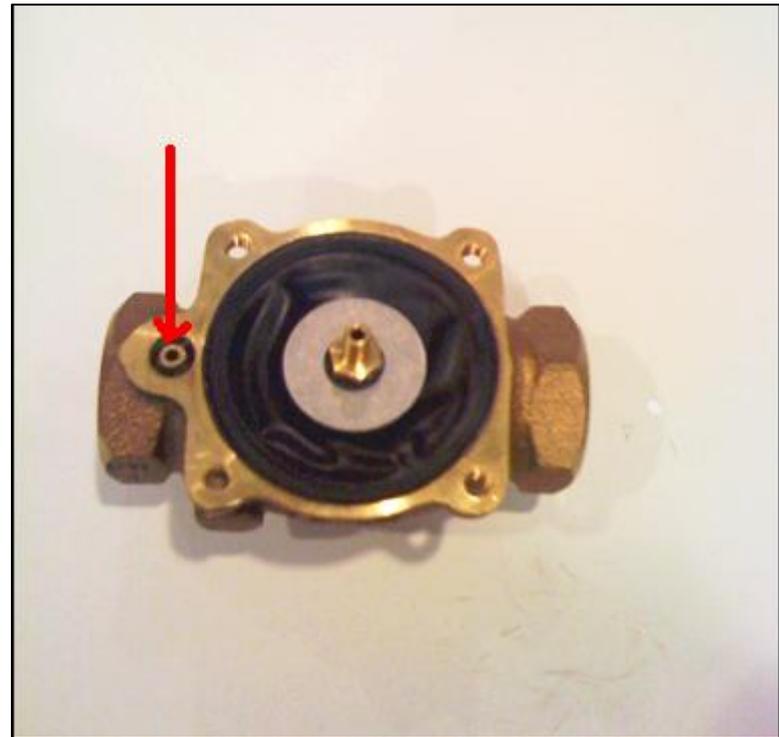
PROBLEM: Water leaks out of valve between bonnet and body in area below solenoid.

CAUSE: Damaged or missing exhaust o-ring.

SOLUTION: Remove bonnet and replace o-ring. It may be necessary to scrape remnants of the o-ring from the o-ring groove using a sharp object. This is because the o-ring was set in groove with epoxy.

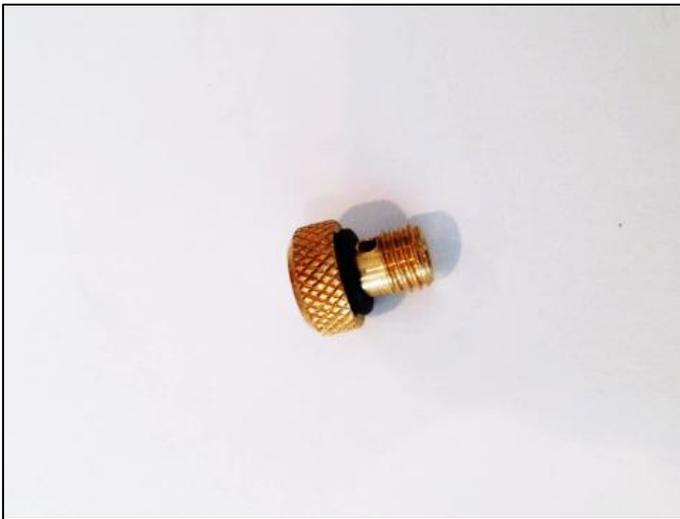
PROBLEM: Water leaks out around manual bleed screw.

CAUSE #1: Damaged o-ring on manual bleed screw.

SOLUTION: Replace manual bleed screw.

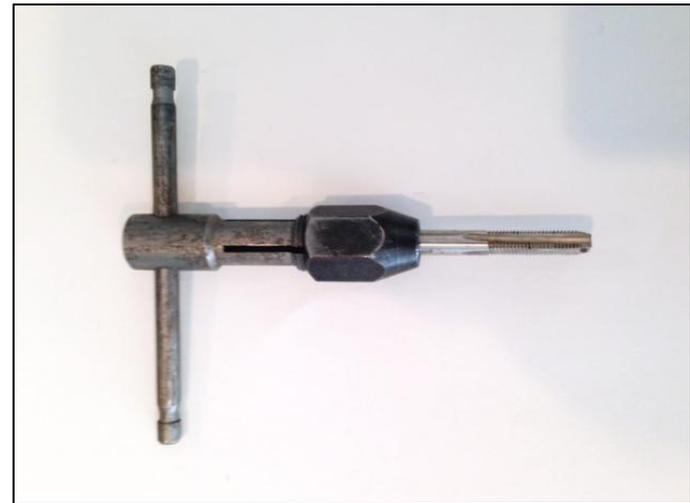
PROBLEM: Water leaks out around manual bleed screw.

CAUSE #2: Bleed screw unable to screw all the way down due to disappearing threads in opening. This is caused by a transfer of metal between threads of bleed screw and female threads in opening.

SOLUTION: Using a 5/16"-24 tap, rethread opening and replace bleed screw with a new one.

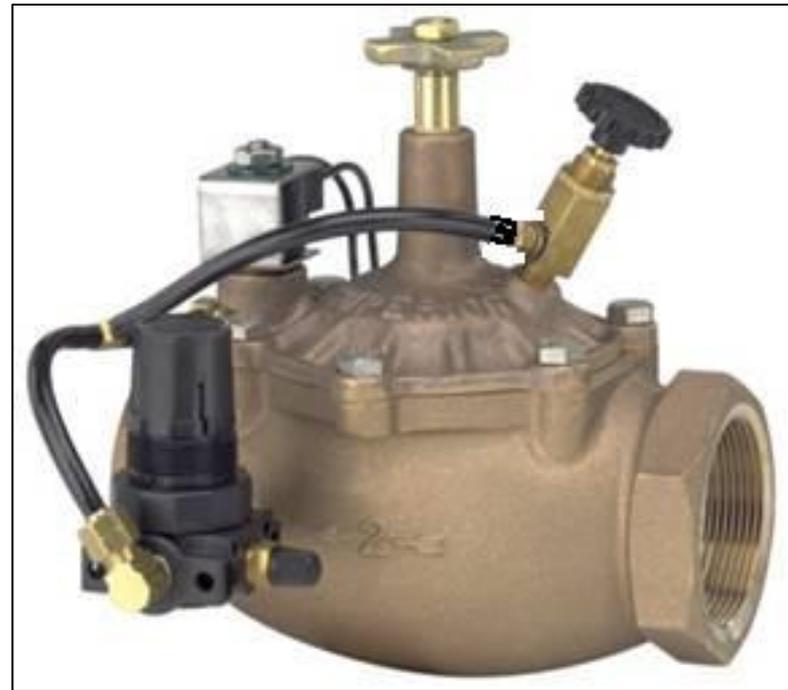
PROBLEM: Water weeps past valve and seeps out of lowest head in system.

CAUSE: If the solenoid has been checked and is OK and the interior of the valve has been checked for debris but none is found, then the likely cause is a defective manual bleed valve. To verify, remove the plastic tubing from the barbed fitting on the manual bleed valve. The best way is to slit the end of the tubing about $\frac{1}{4}$ " with a knife or razor blade and pull the tubing off of the barb. If water, even a very small amount, exhausts from the manual bleed valve when it is in the "off" position, then the manual bleed valve is defective.

SOLUTION: Replace the manual bleed valve and reconnect the tubing after slicing the end of the tubing just below the slit that was made in order to remove the tubing.

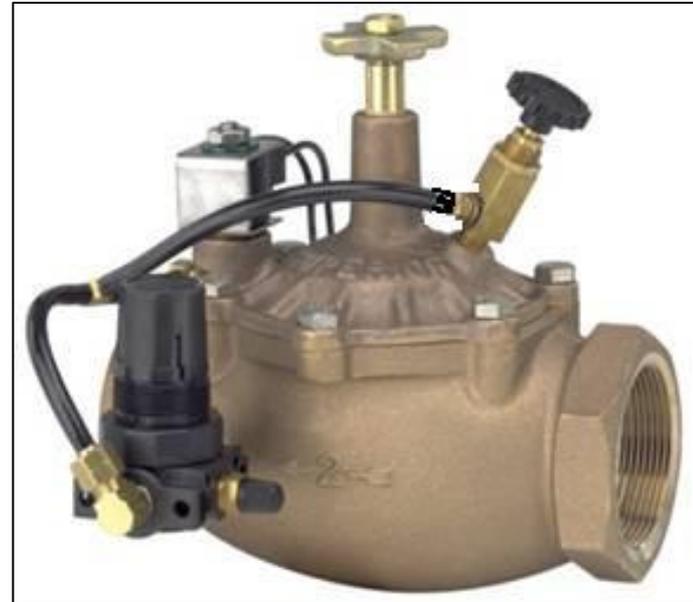
PROBLEM: Valve will not open electrically or by opening the manual bleed valve.

CAUSE: Adjustment knob on regulator is in “off” position preventing water from passing thru regulator.

SOLUTION: Open manual bleed valve by turning handle in counter-clockwise direction. Next, raise knob on regulator to unlock it, then rotate knob clockwise, a half turn at a time, until water begins to pass thru valve. Wait until system is fully pressurized then continue to rotate knob clockwise until desired setting is reached. Next, push down on regulator knob to lock it in place, then close manual bleed valve.
